Nail Pops on Asphalt Roofs

Introduction

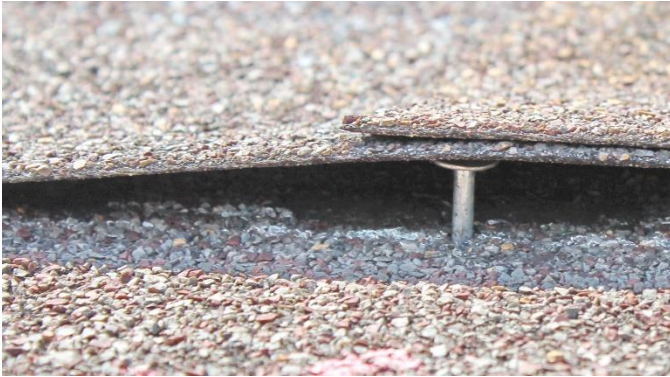
A protruding nail is a common problem found on residential roofs with asphalt shingles. The roofing industry refers to these as Nail Pops. The image below shows a typical Nail Pop.

The nail actually pops up and out of the wood deck causing the shingle to be lifted. The nail backs out of the wood deck where it once had been adequately inserted to the correct depth.

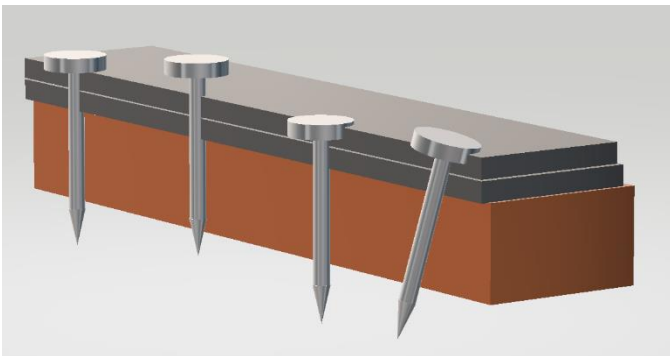
This should not be mistaken for nails that are incorrectly installed, which does happen. Nails that are incorrectly installed would be nails that are under-driven, over-driven, or driven at an angle to the surface.

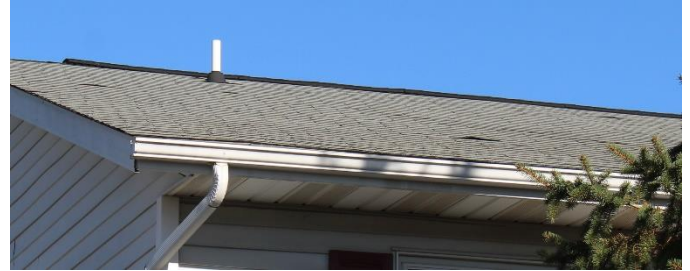
Do not be fooled. It is common for people to view their roof from the ground and incorrectly come to a false conclusion of wind damage. The following image shows

several lifted shingles as seen from the ground. Wind does lift shingles, but this roof has nail pops.

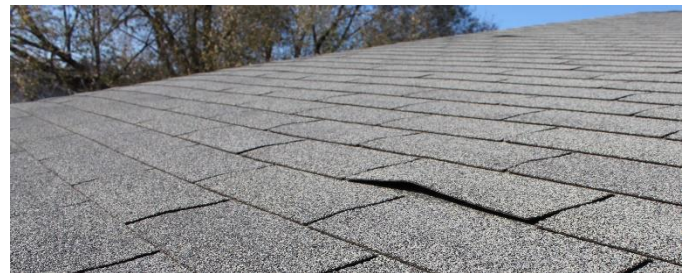
When viewing the distortion from the roof, a shingle may be found to be in an upward position due to a nail head. The image below shows a shingle tab being pushed upward by a nail. It cannot lay flat.

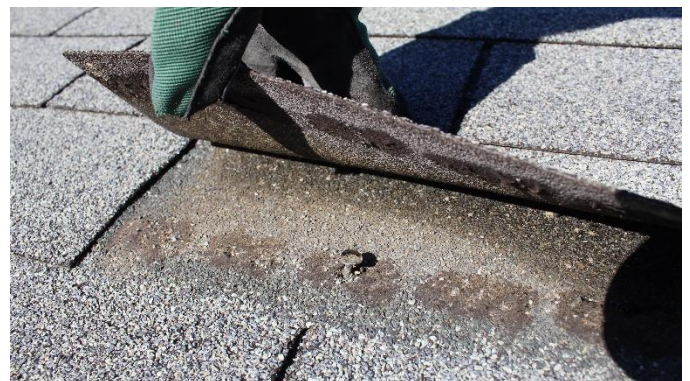
A correctly installed nail will be located just below the sealant strip. The image below shows a nail within the sealant strip. The shingle tab was no longer sealed. The nail had stepped out approximately ¼-inch.

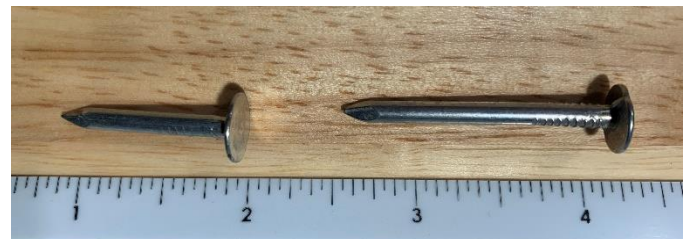
Often the problem occurs when the nail is not adequately installed. Nails are required to fully penetrate a roof deck. If a roof has two layers of shingles, longer nails must be used to have the nail fully penetrate the deck.
