The Roof is Damaged – Can it be Repaired?

By Richard T. Abbott, PE
Abbott Consulting Forensics and Design

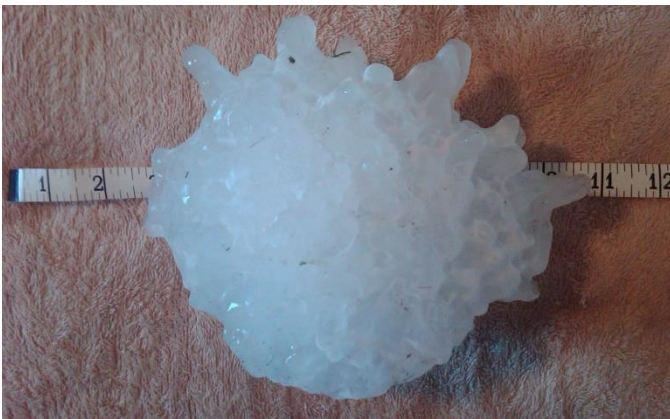
A simple web search on, "Record Setting Hail Event" will result in photos of massive hail. According to the National Weather Service (NWS), on 7/23/2010 Vivian, South Dakota had extremely large hail. A hailstone was found that measured 8.0 inches in diameter.

Question: What can stop this missile from plummeting to earth at some ungodly velocity?

Answer: Not much can stop it without incurring damage. Do we really need to ask other questions when this hits a roof? Nothing is really made to stop hail this size unless we are talking about storm shelters.

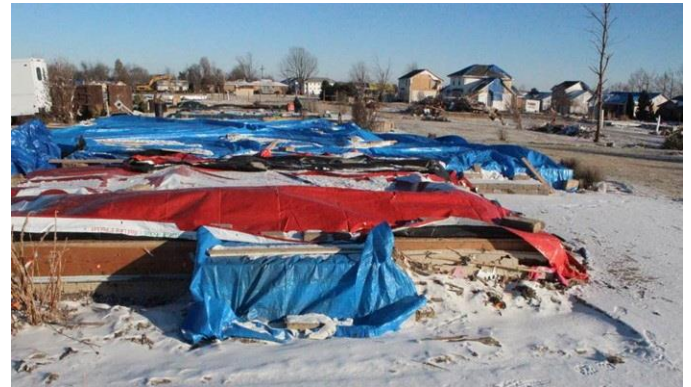
Tornado winds are just too strong for residential homes. In this case, there was no roof to be repaired. There was no roof structure to install asphalt shingles.

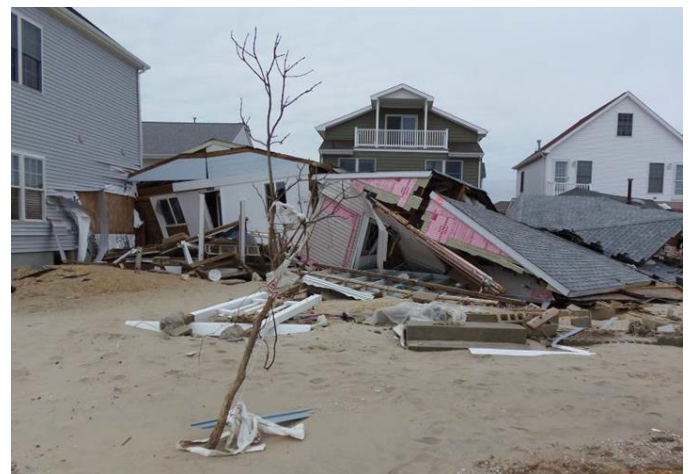
Hurricanes can have a storm surge where the moving water can be violent. A closer look at the roof shingles on this collapsed building showed no missing roof shingles.

It may seem like a meaningless observation, but if wind were to be blamed for a collapse, there should be other items damaged by wind.

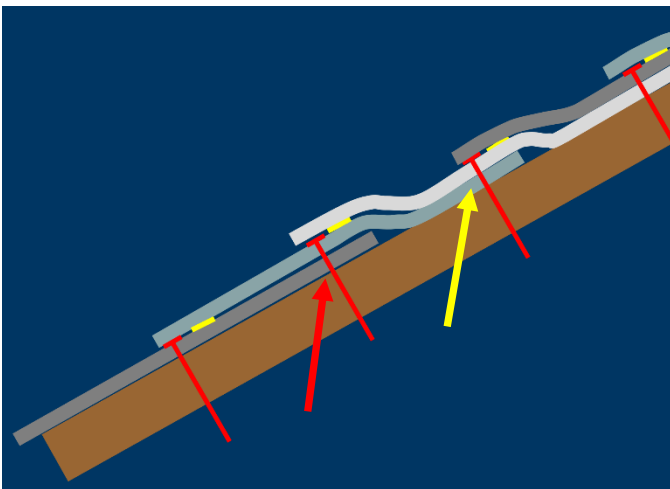
The contractor told the owner that the local building code required that all the roof shingles above the damaged area need to be replaced in a V-pattern up to the ridge due to code language citing paragraph R908.5 of IRC.

The image below describes the problem. The image is a cross section through the layering of an asphalt shingled roof. Assume the light blue shingle in the middle of the image needed to be replaced, the two nails securing the shingle would need to be removed. This leaves holes:

- holes at the top of the lower shingle (red arrow)
- holes at the mid-point of the upper shingle (yellow arrow)

Answer: The contractor was in error of his interpretation of the code for the following reasons:

1. Strictly reading the code, the shingles below and above an isolated repair are not taken off the roof and reinstalled; therefore, this section of the code does not apply to undamaged shingles.
2. Asphalt shingled roofs have been successfully patched on numerous roofs for years. It has been a long-time approved method of repair.
3. There are no asphalt roof manufacturer's stating that their product cannot be repaired.
