Asphalt Roofing: Wind or Hail Damaged vs. Deterioration

by Rick Abbott, PE, SE

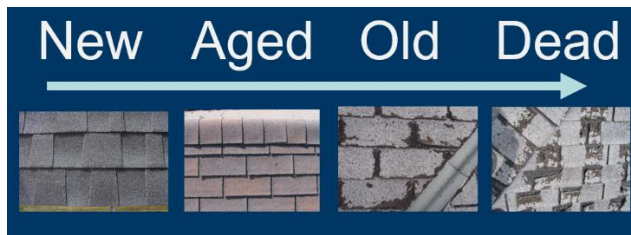
The primary reason for the disparity in views of granule loss being considered as hail damage is due to the lack of clearly evaluating a roof's existing condition prior to the hail event. A roof's pre-existing condition must be taken into account when evaluating a specific roof for a specific hail event. All asphalt roofs age. It is normal and expected that the shingles will deteriorate overtime. A roof will transform from new to old, and will eventually exceed its useful service life. The deterioration is on a sliding scale of time as shown below.

In the absence of a hail event, granule loss is considered normal wear. Shingles are expected to resist weathering within limits. Granules release from a shingle over the life of the shingle at different rates during the course of a life of a shingle. In the early years, granules described as "hitchhiker granules" release soon after installation. Hitchhiker granules are not sufficiently embedded in the asphalt and easily fall off the roof. After the initial release of these "hitchhiker granules", the granules will release from the shingles at a slower rate. The granules release from the asphalt layer due to thermal cycling and a general breakdown of the shingle. Toward the end of the life of a shingle, the granule loss rate will increase again as the asphalt becomes more brittle. When shingles are left on a roof beyond their service life, the end condition of a roof often consists of portions of the roof having heavily deteriorated shingles with little or no granules. Leaks may even be present.

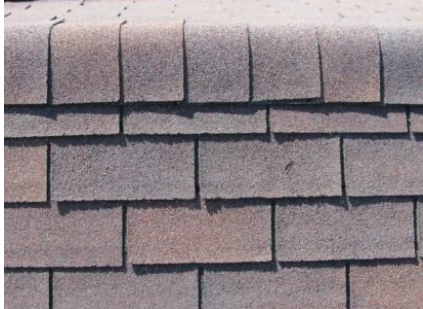
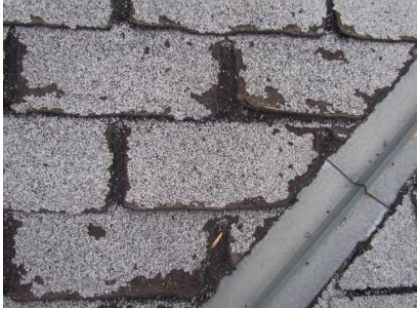
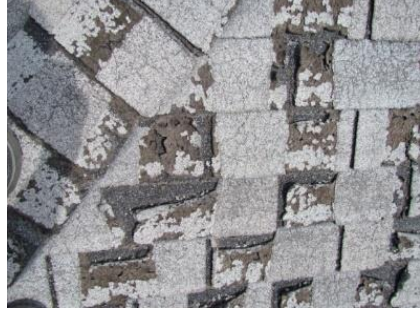
Early Stage (Slight Deterioration)	Middle Stage (Moderate Deterioration)	Advanced Stage (Severe Deterioration)
Description (form): Shingle tab edges are curled. The surfaces of the shingle tabs are not flat, but have slight bump or ridges.	Description (form): Granules have come off, leaving the mat exposed in localized areas. Granules easily flake off the shingle.	Description (form): The mat is disintegrated. The shingle tabs are missing or holes are present. The roof should not be walked on.
Function: Shingles are able to shed water.	Function: Shingles are able to shed water.	Function: Not functioning. Leaks are likely.

Focusing on the resistance side of this problem, it is clear that a roof must be evaluated for function and form. Below are simplified descriptions (the form) of three stages of a deteriorated roofs and their ability to shed water (function):

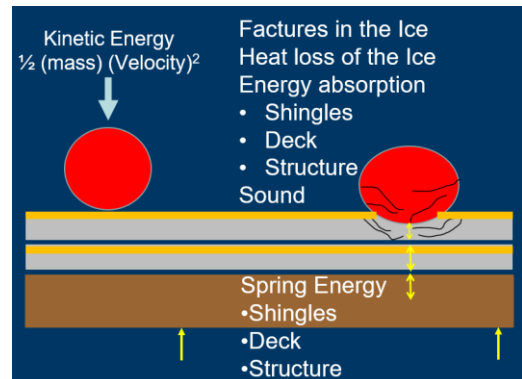
When the hail comes to rest after the impact to the roof, the kinetic energy changes into other types of energy. Below is a representation of the energy conversion:

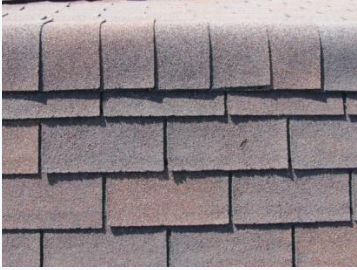
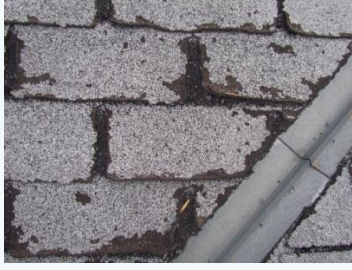
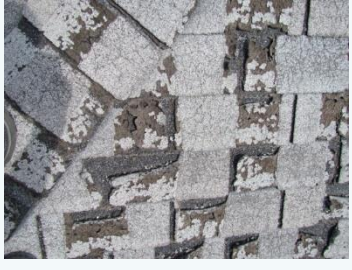
Early Stage (Slight Deterioration)	Middle Stage (Moderate Deterioration)	Advanced Stage (Severe Deterioration)
Integrity to resist hail impacts	Some, but the top layer is delaminating making it easier to flake. The shingles are more brittle.	Little to no resistance to impact. Granules easily flake off with the slightest effort.	None
Criteria used for "Hail Damage"	Treat similar to a new roof.	Depression of the mat, along with mat fracture. Granule loss is not a considered loss since it easily releases from the roof.	None. Hail cannot damage a shingle that has no integrity. If the roof is leaking and looks terrible prior to a storm no further damage and occur.

Based on the above discussion, the table below summarizes, reasonable criteria for evaluating existing roofs for their integrity to resist hail, and for determining if hail has damaged a deteriorated roof.

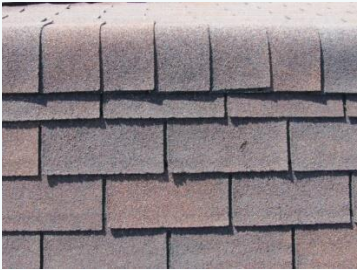
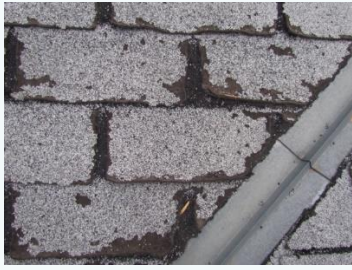
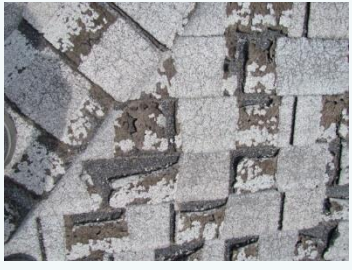
Early Stage (Slight Deterioration)	Middle Stage (Moderate Deterioration)	Advanced Stage (Severe Deterioration)
Integrity to resist wind load	Some, but definitely weakened due to curled edges and deteriorated sealant strips.	Little or no resistance to wind. Shingles are unsealed, and easily lifted.	None
Criteria used for "Wind Damage"	Treat similar to a new roof. Creased, flipped, missing, or whole sections missing or lifted.	Whole sections missing and roof is cleaned. No loose granules remain after a wind storm.	Dead. If it is still on the roof and looks like this, wind did not damage it. Deterioration is the cause. The roof has exceeded its useful service life.

Based on the above discussion, the table below summarizes the condition of a deteriorated roof and its ability to resist wind loads. It also gives reasonable criteria for determining if wind has damaged a deteriorated roof.

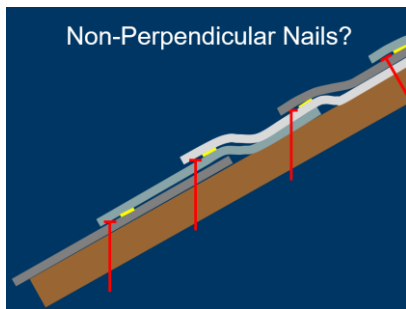
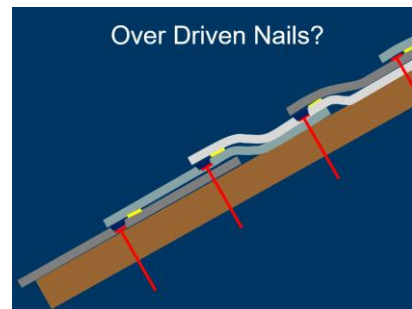
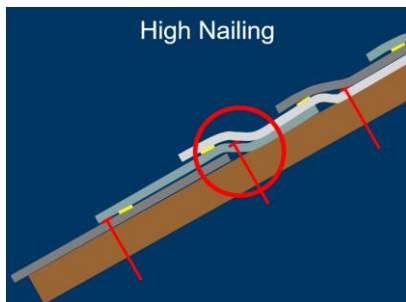
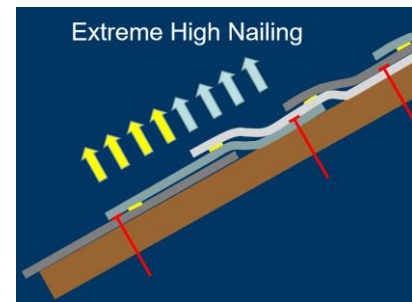
A number of installation errors have been identified as causing roof shingles to be prone to wind damage include the following:
