Lesson 4: The Building Envelope

Example 5 : Wind Driven Rain

Example 6: Liquid from the Outside

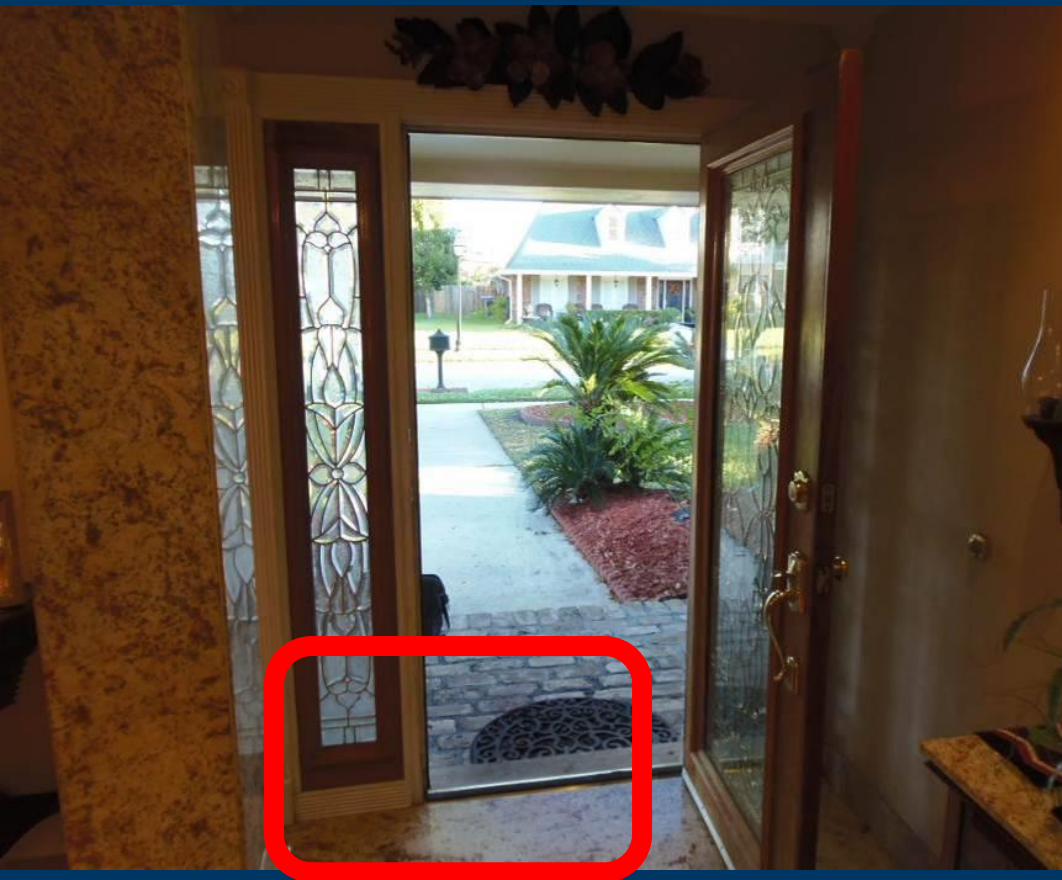
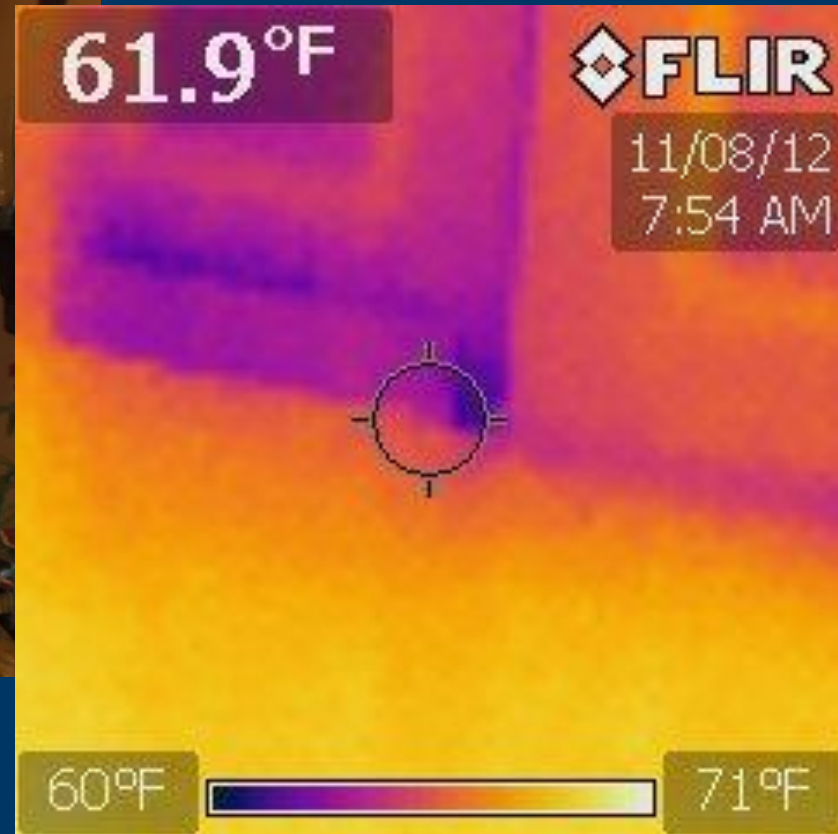
The outside temperature was 60 degrees. The inside temperature was 70 degrees

An infrared camera was used to detect cool outside air entering the house at the lower bottom corner of the door.

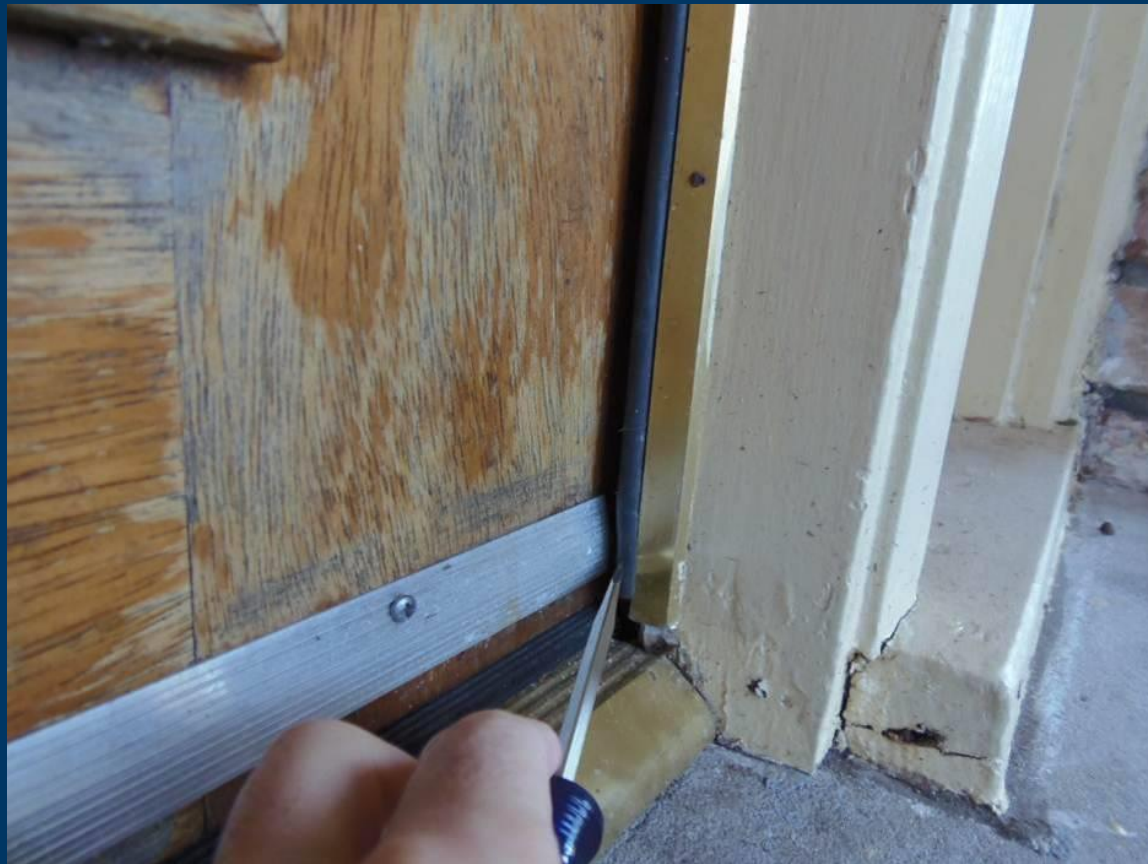
Origin
(Source + Path) = Hurricane (wind and rain)
+ a hole at the base of door

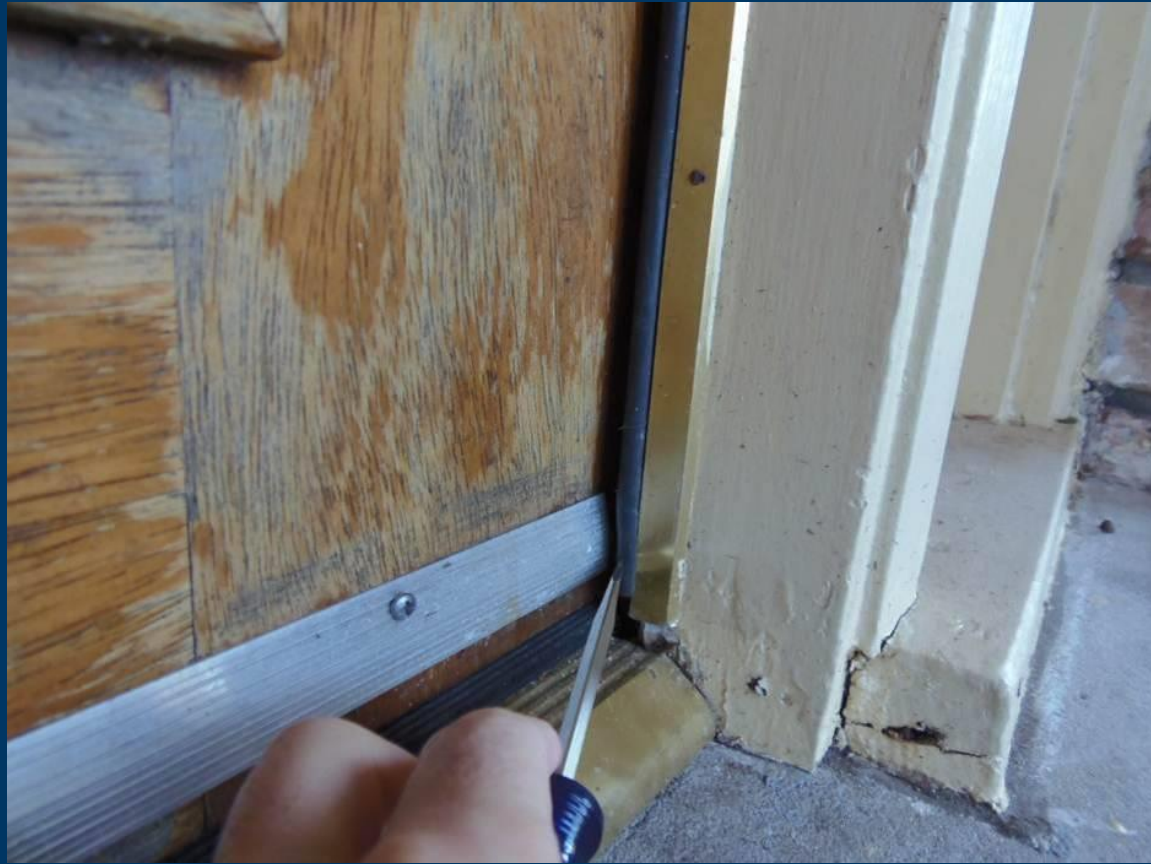
Cause: What one thing? =

Not installed
adequately

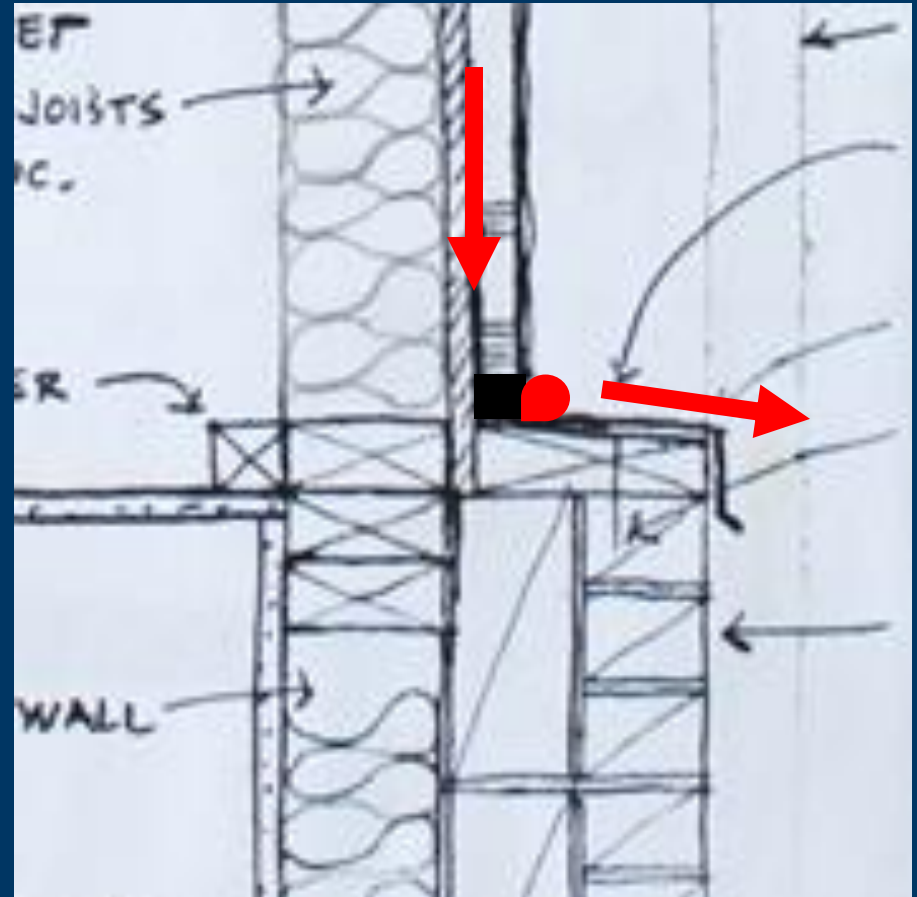
EIFS exterior insulation finish system

The EIFS was not allowed to drain at the metal flashing

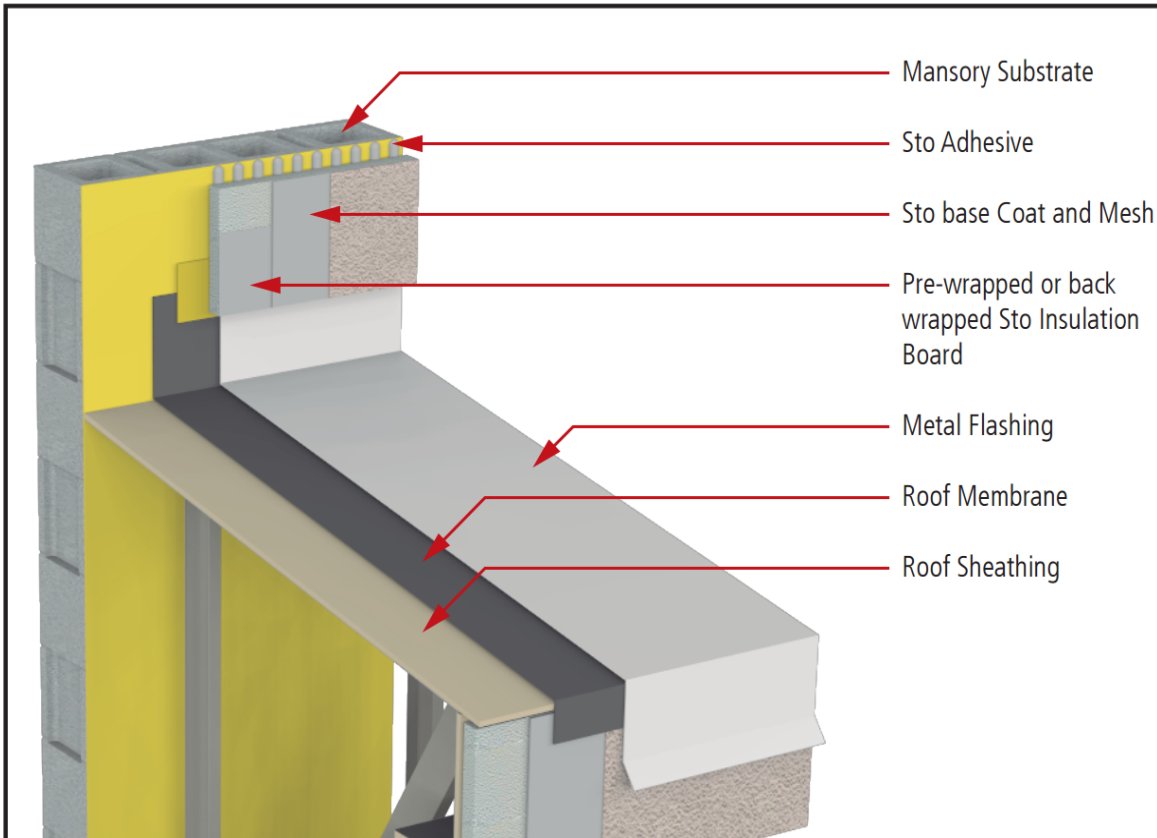
Detail No.: 19.53

StoTherm® ci Over Masonry Termination at Built-Out Feature

- 1) Terminate StoTherm® ci minimum 2 inches (51mm) above metal flashing with minimum 2 inch (51mm) overlap of flashing.
- 2) Provide sealant beneath flashing drip edge.
